Haven for Turacos

Text and photographs of David's turacos by Ron Toft

My New Aviary Construction by David Jones

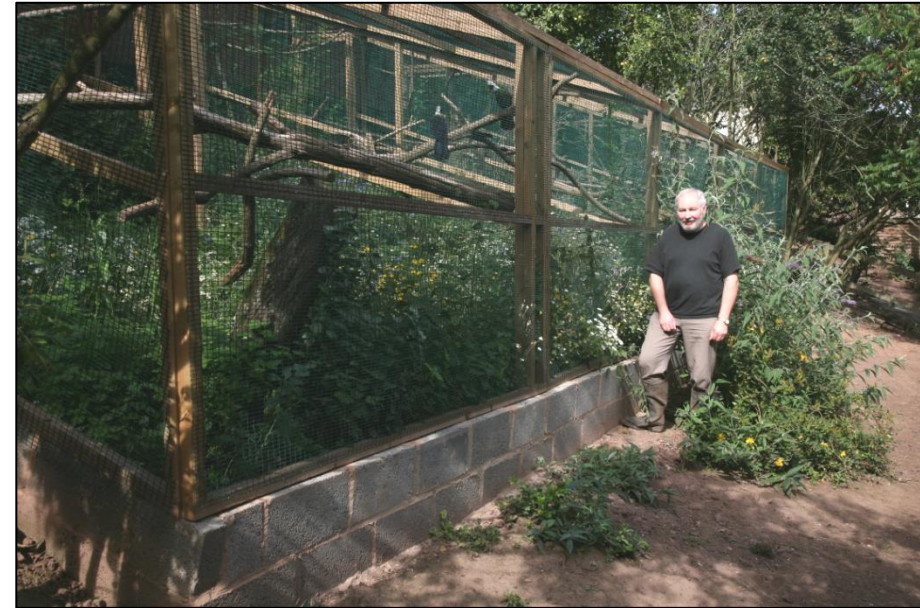
David standing outside his new flights

David's six new aviaries are now more or less finished. All the footings were dug by hand. "We then put down a concrete base, on top of which we laid two layers of breeze blocks. The pressure-treated wood and wire aviaries basically sit on top of these blocks."

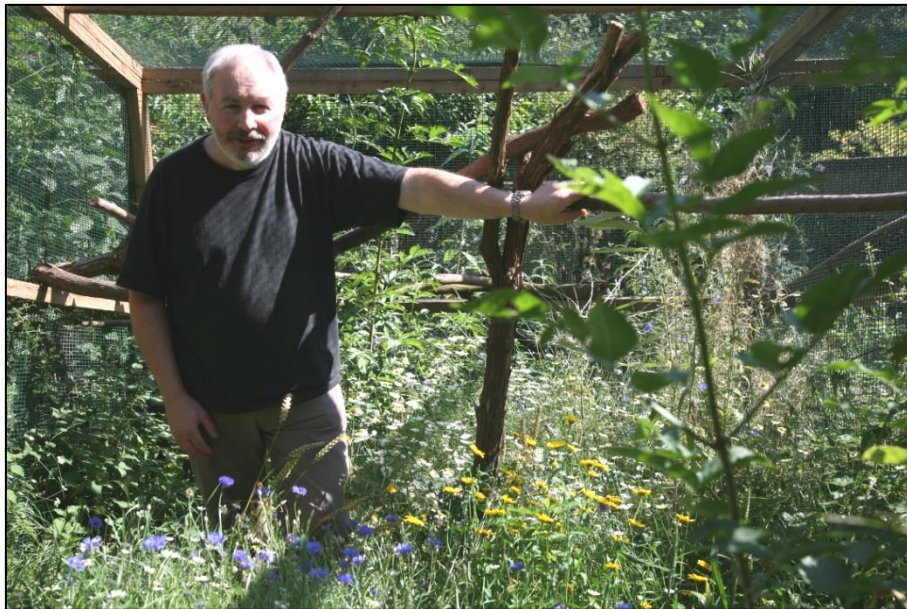
David inside one of his new planted aviaries

The bare ground inside the six aviaries was seeded with grass and wildflowers and was a multi-coloured mini meadow when I visited David in late August.

“The birds don’t actually need all these plants, but they give the aviaries an attractive, natural look. More importantly, they knit the soil together and will prevent the floor becoming awash with mud in winter.”

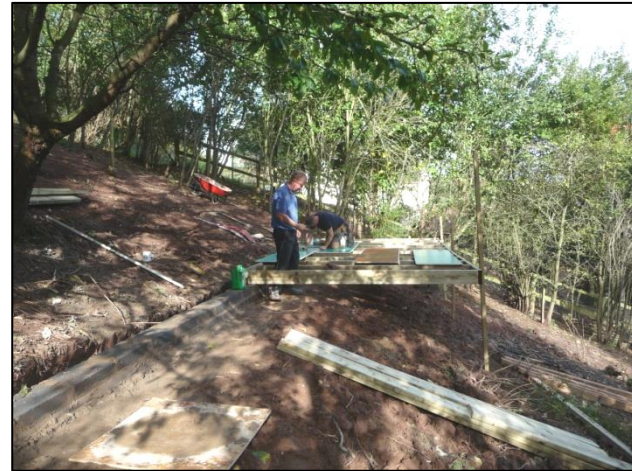
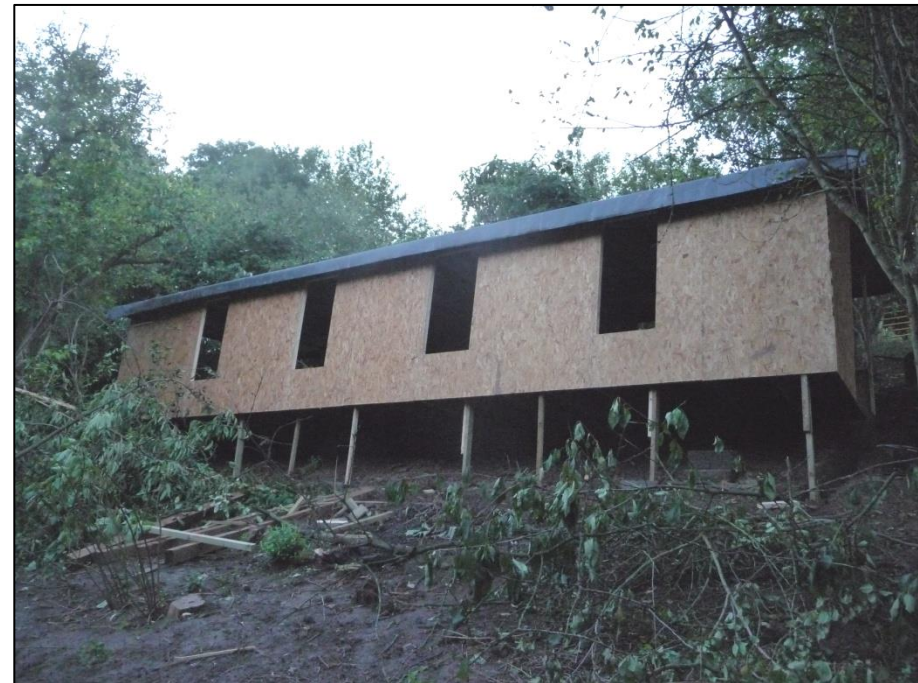
Corden and his brother Mark, who built my flights with very limited help from me! We cleared the land and dug in for the concrete footings to support the back of the shelter, with the front of the shelter resting on stilts.

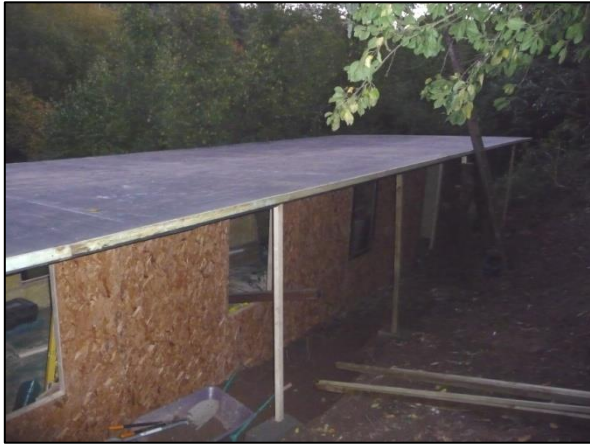
The roof was covered in a single sheet of rubber, edged with timber slats.

“All the timber, however, was new, as was the sheet of rubber I bought to cover and protect the roof of the bird room. The rubber came in one large sheet. After rolling it into position, it is edged with timber. The beauty of using rubber as a roofing material is that it is guaranteed for 25 years, whereas the felt on a new shed I have is leaking already. Felt is hopeless.”

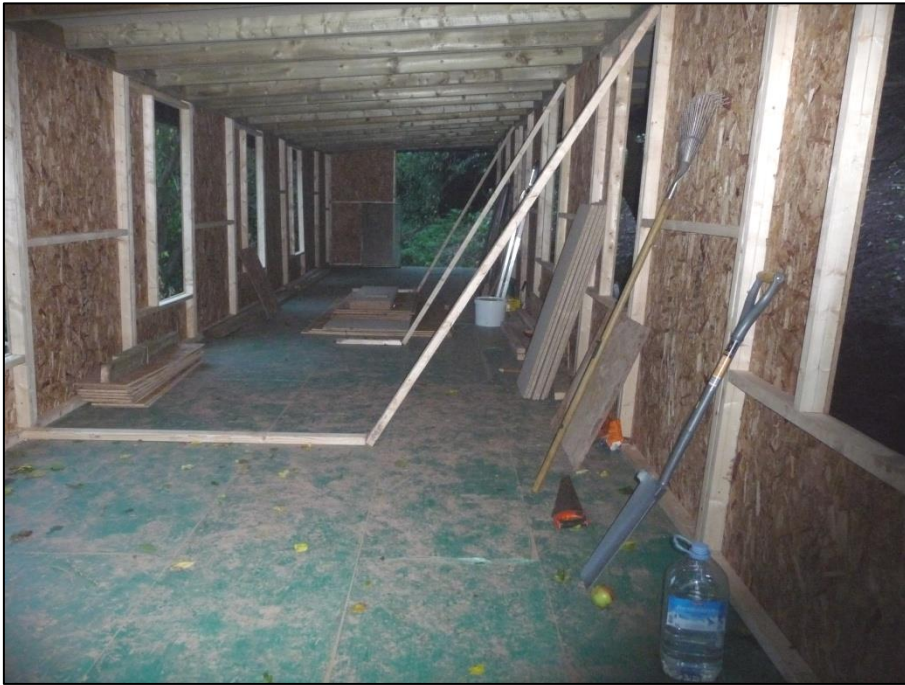
Inside the walls were insulated with 2" thick fibreglass which was covered with another layer of plywood.

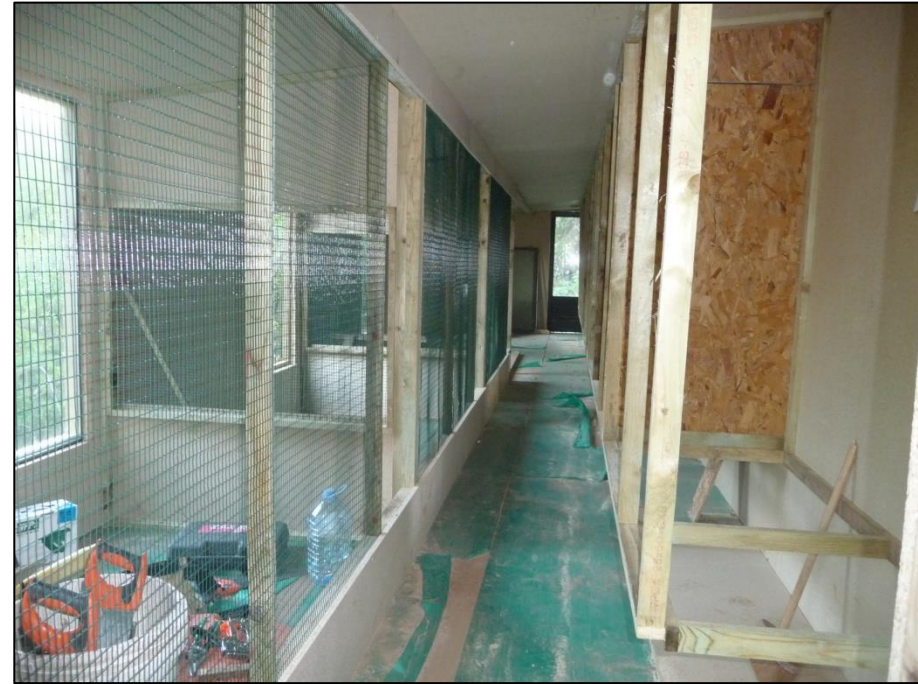
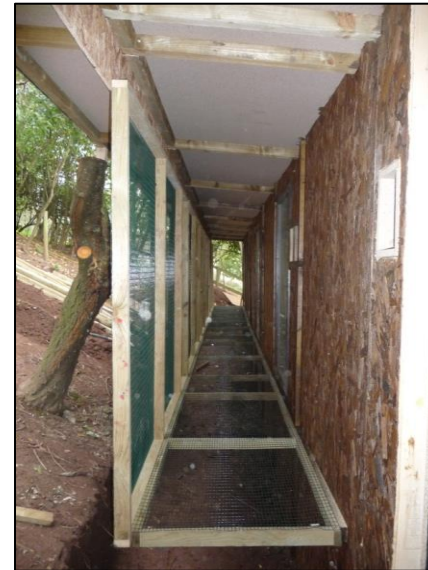
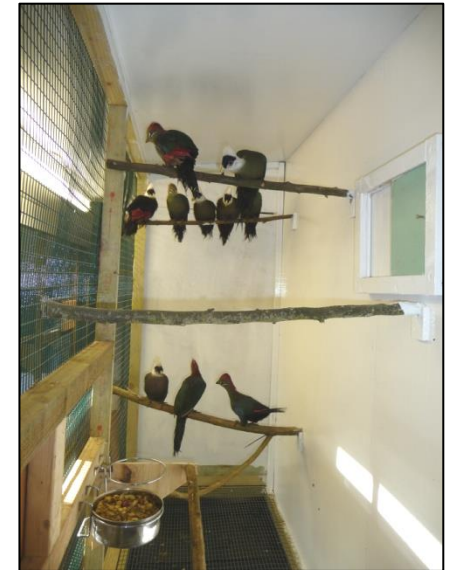
The inside pens were then constructed with 5 larger enclosures for adult pairs of turacos on one side, another enclosure at the far end and 5 smaller pens for young stock on the other side. The pens for young birds were raised up off the floor so droppings would fall through the wire onto trays, which can be pulled out for cleaning.

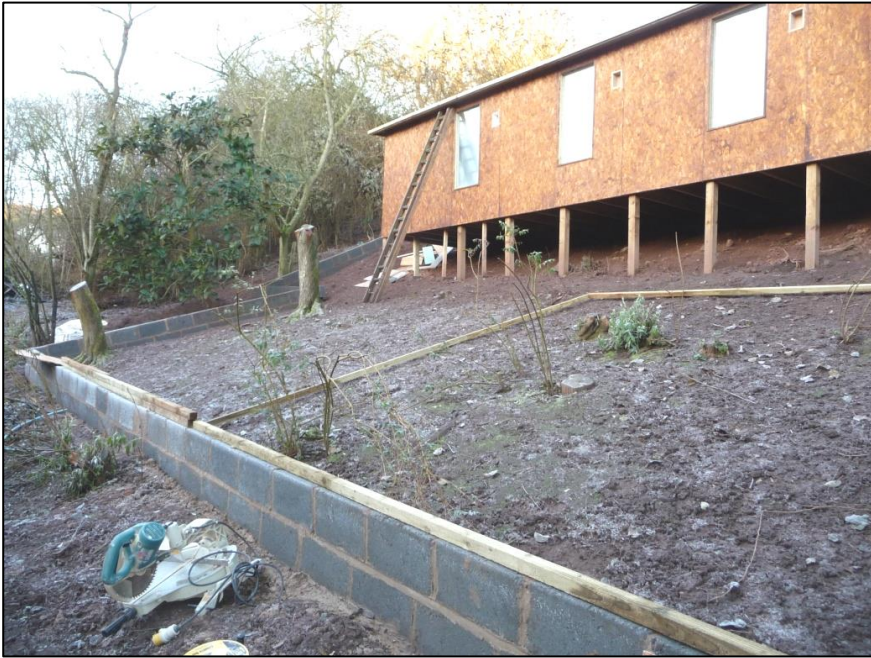
Behind the shelter outside, 5 raised pens were built which connect via pop holes to the 5 youngsters' pens inside. Sliding dividers between the pens give versatility as to how big the pens are at any time.

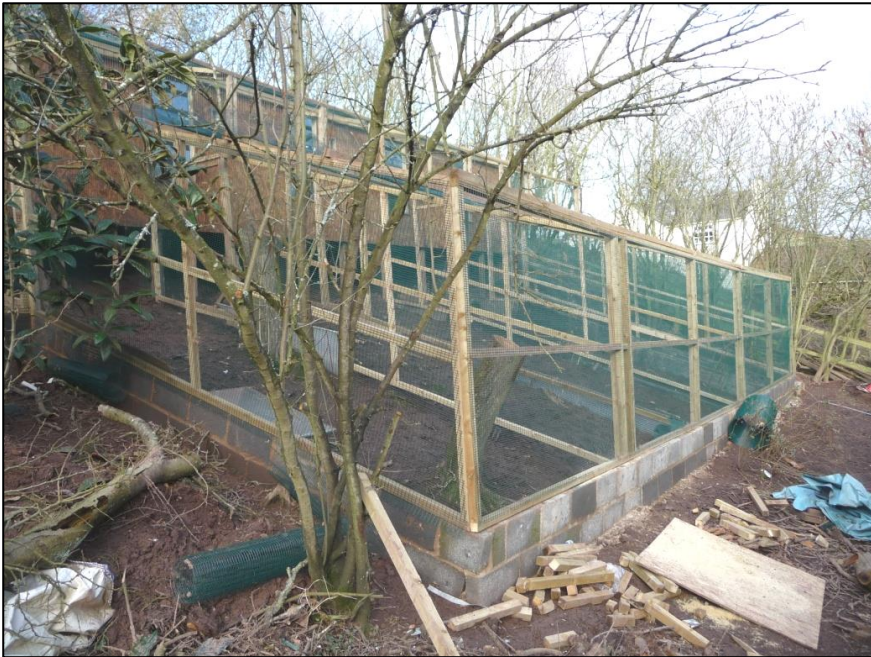
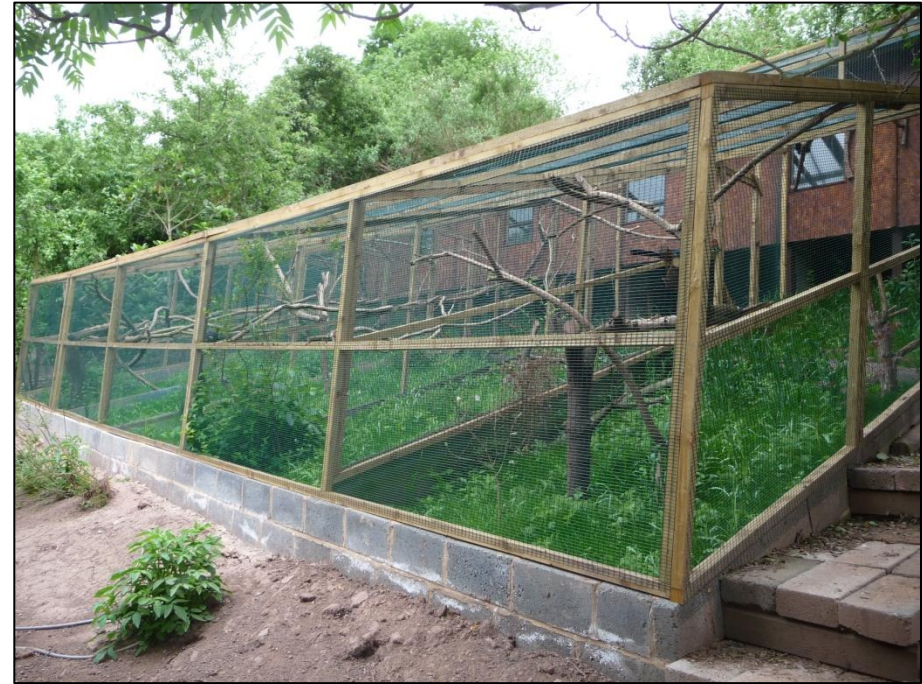
Outside, concrete footings support 2 layers of breeze blocks upon which sits a 2x2" timber frame covered in green coated 1x½" weld mesh. There are 5 pens along the front with a 6th pen at the end.

Natural perching was added and grass and wild flower seeds were sown before the turacos were introduced to their new homes.
